# **Lake St. Helen Aquatic Vegetation Management Plan with Professional Management Recommendations Roscommon County, Michigan**

**Provided for: Lake St. Helen Association Board**

**Prepared by: Restorative Lake Sciences  
Jennifer L. Jermalowicz-Jones, PhD, CLP  
Water Resources Director  
18406 West Spring Lake Road  
Spring Lake, Michigan 49456  
[www.restorativelakesciences.com](http://www.restorativelakesciences.com)**

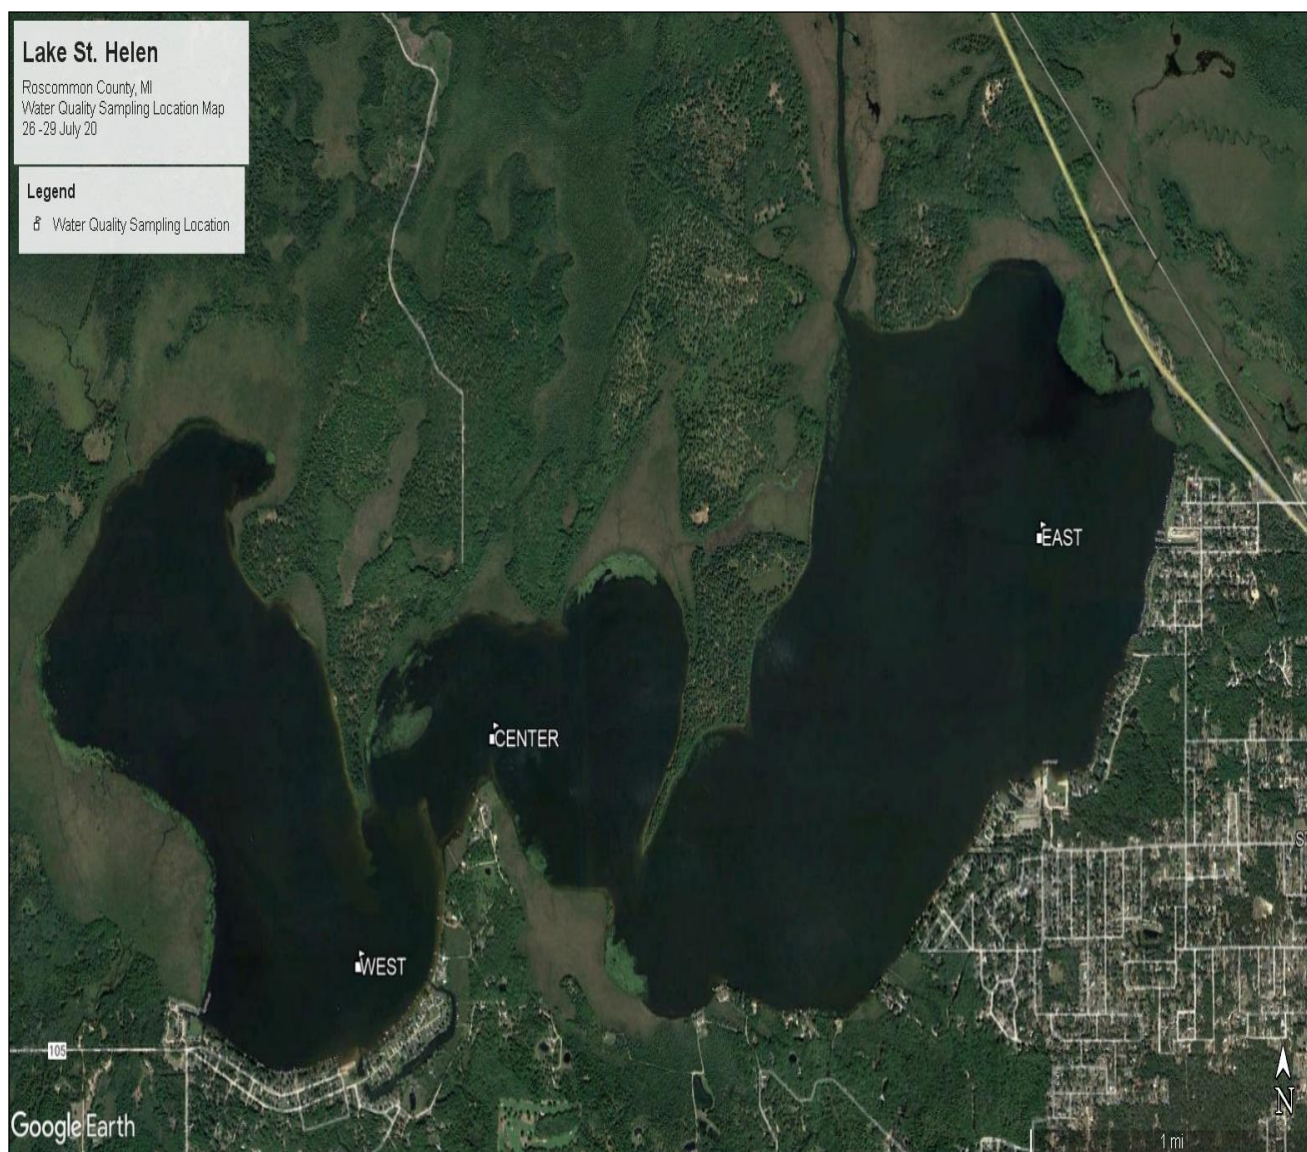
**Figure 4. Locations for water quality sampling of the 3 basins in Lake St. Helen (July 29, 2022).**

Parameters such as, but not limited to, dissolved oxygen, water temperature, conductivity, total dissolved solids, pH, total phosphorus total Kjeldahl nitrogen, chlorophyll-*a*, and Secchi transparency, are critical indicators of water quality. On July 29, 2022, Restorative Lake Sciences collected water samples from within 3 deep basins in Lake St. Helen. The results are discussed below and are presented in Tables 3-5. A map showing the sampling locations for all water quality samples collected from the deep basins is shown below in Figure 4. All water samples and readings were collected on July 29, 2022 with the use of a Van Dorn horizontal water sampler and calibrated Eureka Manta II® multi-meter probe with parameter electrodes, respectively. Chlorophyll-*a* was measured *in situ* with a calibrated chlorophyll-*a* meter from Turner Designs®. All other water quality samples were analyzed at NELAC-certified Trace Analytical Laboratories in Muskegon, Michigan.

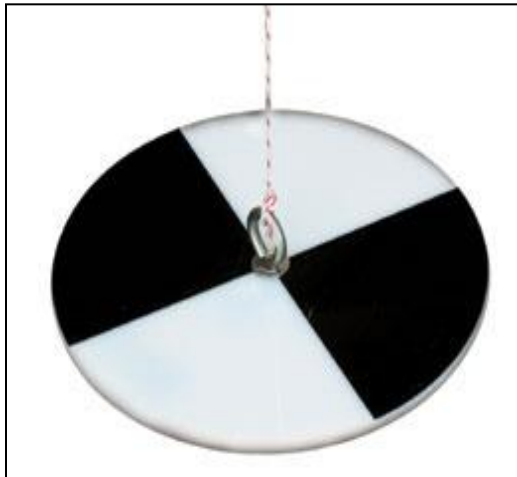
Figure 5. A Secchi disk

Secchi transparency is a measure of the clarity or transparency of lake water, and is measured with the use of an 8-inch diameter standardized Secchi disk (Figure 5). Secchi disk transparency is measured by lowering the disk over the shaded side of a boat around noon and taking the mean of the measurements of disappearance and reappearance of the disk. Elevated Secchi transparency readings are usually correlated with increased aquatic plant and algae growth and higher suspended solids. Eutrophic systems generally have Secchi disk transparency measurements less than 7.5 feet due to turbidity caused by excessive planktonic algae growth. Further, elevated phytoplankton and turbidity, also are associated with decreased Secchi transparency. **The Secchi transparency of Lake St. Helen ranged from 3.8-7.1 feet over the deep basins of Lake St. Helen during the July 29, 2022 sampling event.** This transparency is adequate to allow abundant growth of algae and aquatic plants in the majority of the littoral (shallow) zone of the lake and is likely higher when the water temperatures are cooler and less algae is present. Lake St. Helen contains a fair amount of tannins in the water which imparts a tea-color stain to the water. Tannins are a natural component of the lake being adjacent to large forests and wetlands. Secchi transparency is variable and depends on the amount of suspended particles in the water (often due to windy conditions of lake water mixing) and the amount of sunlight present at the time of measurement.

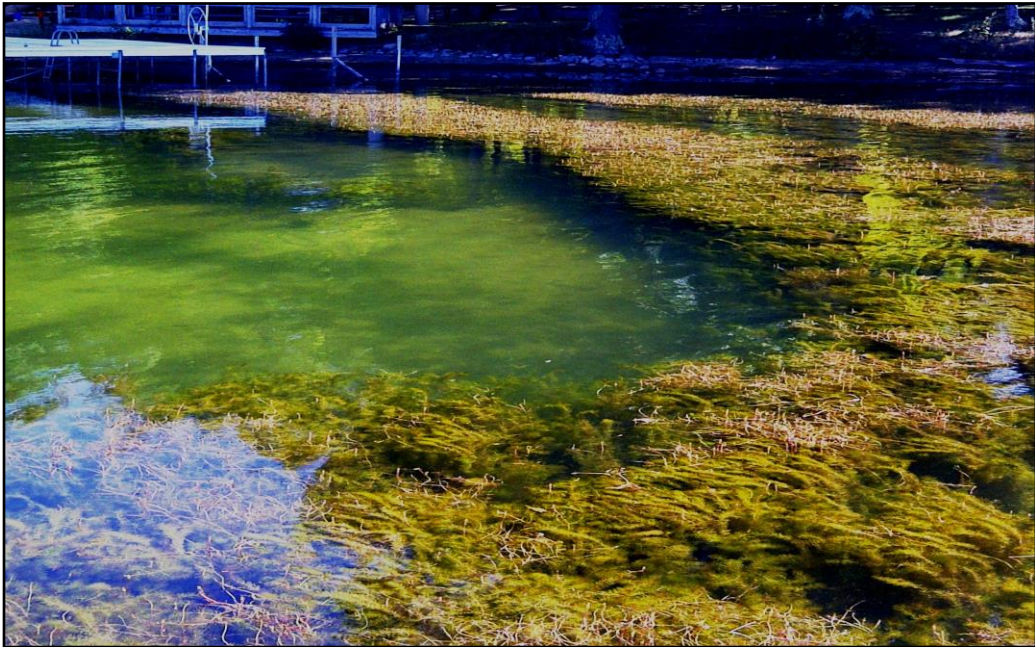
**Figure 9. Hybrid Eurasian Watermilfoil Canopy on an inland lake (©RLS).**

**Approximately 614.3 acres of Eurasian Watermilfoil was found in Lake St. Helen during the July 26-29, 2022 survey (Figure 10) and an intensive management program is proposed below.** Eurasian Watermilfoil growth in Lake St. Helen is capable of producing dense surface canopies in shallow areas. The species of invasive aquatic plants present, and relative abundance of each plant are recorded and then the amount of cover in the littoral zone is calculated.

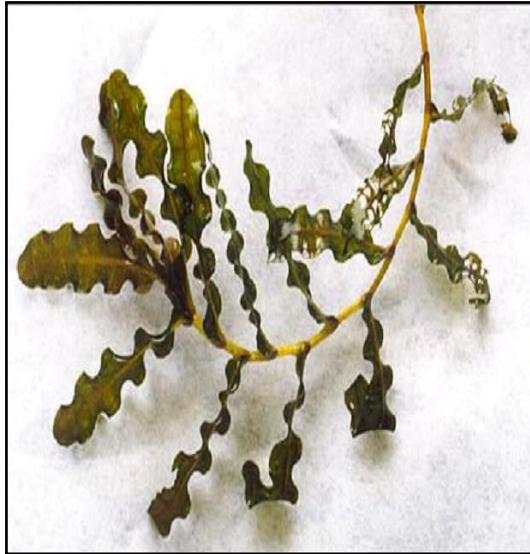
**Figure 11. Curly-leaf Pondweed ©RLS**

**Curly-leaf Pondweed (*Potamogeton crispus*; Figure 11)** is an exotic, submersed, rooted aquatic plant that was introduced into the United States in 1807 but was abundant by the early 1900's. It is easily distinguished from other native pondweeds by its wavy leaf margins. It grows early in the spring and as a result may prevent other favorable native aquatic species from germinating. The plant reproduces by the formation of fruiting structures called turions. The plant does not reproduce by fragmentation as milfoil does; however, the turions may be deposited in the lake sediment and germinate in following seasons. Fortunately, the plant naturally declines around mid-July in most lakes and thus is not likely to be prolific throughout an entire growing season. **Curly-leaf Pondweed is a pioneering aquatic plant species and specializes in colonizing disturbed habitats. It is highly invasive in aquatic ecosystems with low biodiversity and unique sediment characteristics. It was present in a small area of the lake and was not abundant at the time of the survey.**

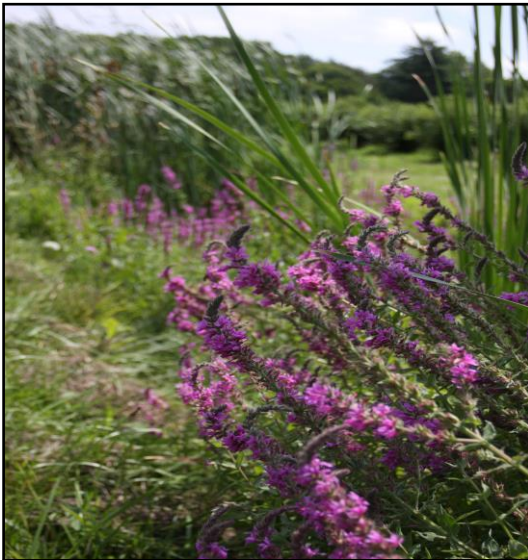
**Figure 12. Purple Loosestrife ©RLS**

Purple Loosestrife (*Lythrum salicaria*; Figure 12) is an imminent threat to the wetland habitat around the lake as it can rapidly displace native emergent aquatic plants. **This plant was found in two locations of the lake.**

4. Purple Loosestrife can be hand-removed without the use of herbicides were it is found. The roots must be removed with a shovel and all of the plant discarded.

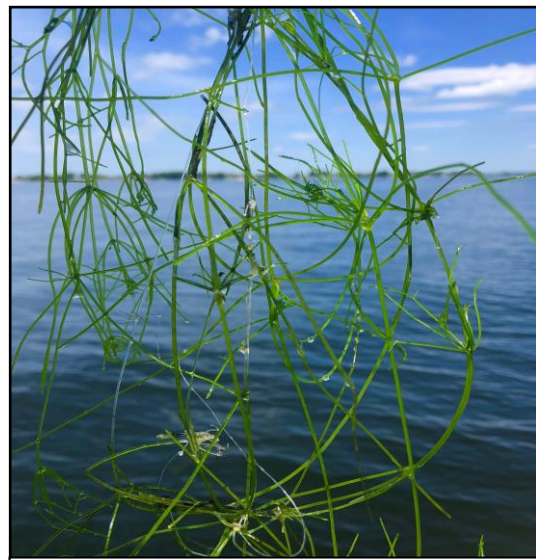
**Figure 13. Starry Stonewort ©RLS**

Starry Stonewort (*Nitellopsis obtusa*; Figure 13) is an invasive macro alga that has invaded many inland lakes and was originally discovered in the St. Lawrence River. The "leaves" appear as long, smooth, angular branches of differing lengths. The alga has been observed in dense beds at depths beyond several meters in clear inland lakes and can grow to heights in excess of a few meters. **It prefers clear alkaline waters and has been shown to cause significant declines in water quality and fishery spawning habitat. Individual fragments can be transported to the lake via waterfowl or boats.**

**These conditions make St. Helen Lake vulnerable to its growth. Approximately 17.3 acres were found throughout the lake, but this may change between surveys and years.**

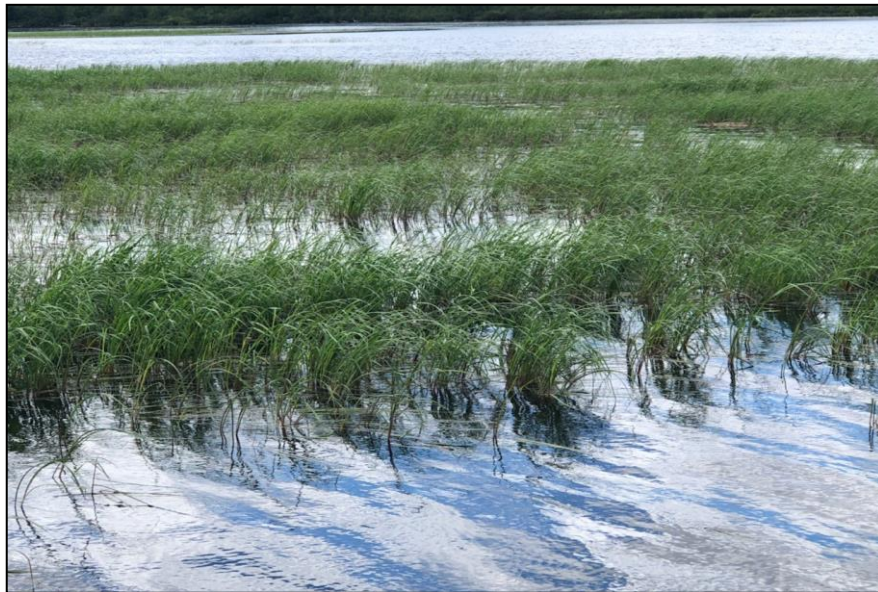
**Figure 16. Dense beds of Wild rice on Lake St. Helen (July, 2022).**

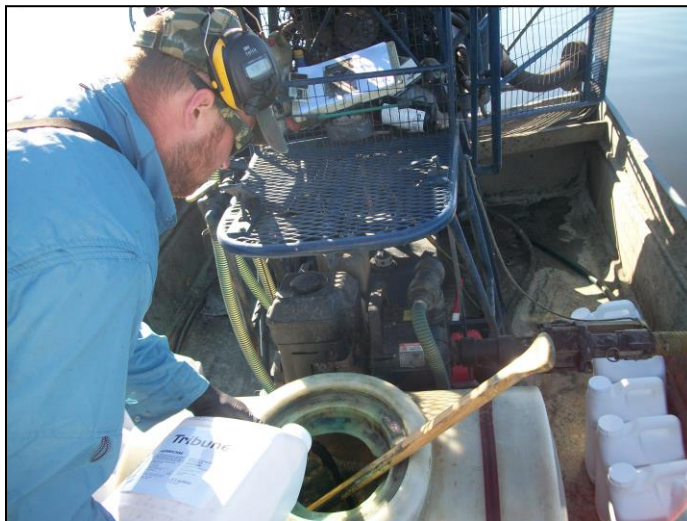
**Figure 48. An herbicide treatment airboat and crew preparing for a lake treatment.**

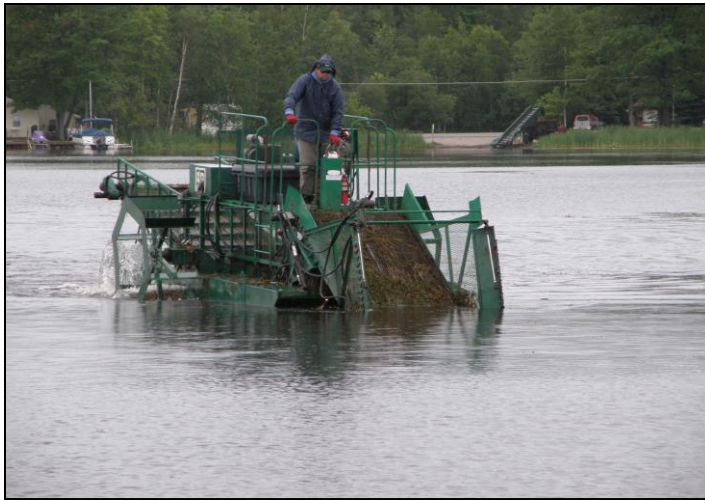
Figure 49. A mechanical harvester.

Mechanical harvesting involves the physical removal of nuisance aquatic vegetation with the use of a mechanical harvesting machine (Figure 49). The mechanical harvester collects numerous loads of aquatic plants as they are cut near the lake bottom. The plants are off-loaded onto a conveyor and then into a dump truck.

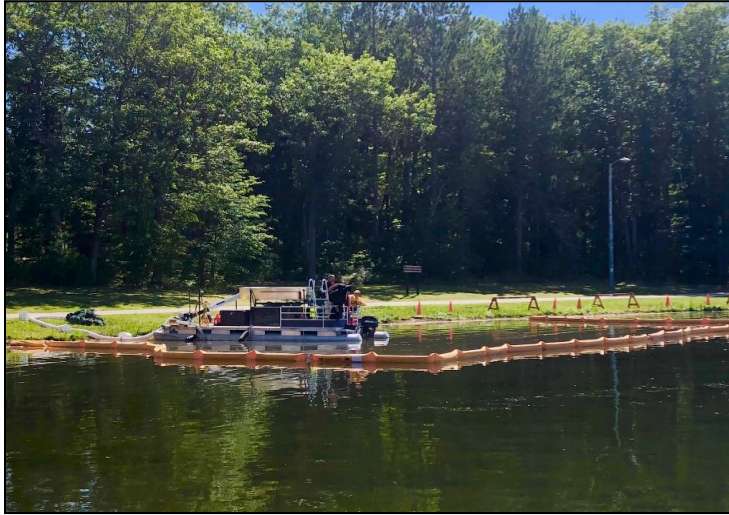
**Figure 50. A DASH boat for hand-removal of watermilfoil or other nuisance vegetation.**  
©Restorative Lake Sciences, LLC

Suction harvesting via a Diver-Assisted Suction Harvesting (DASH) boat (Figure 50) involves hand removal of individual plants by a SCUBA diver in selected areas of lake bottom with the use of a hand-operated suction hose. Samples are dewatered on land or removed via fabric bags to an offsite location. **This method is generally recommended for small (less than 10 acres) spot removal of vegetation since it is usually cost-prohibitive on a larger scale.** The advantage it has is that it can be selective in what species it removes since a diver is guiding the suction hose to targeted plants. This process may remove either plant material or sediments and may require a USACE bottomlands permit. Furthermore, this activity may cause re-suspension of sediments (Nayar et al., 2007) which may lead to increased turbidity and reduced clarity of the water.

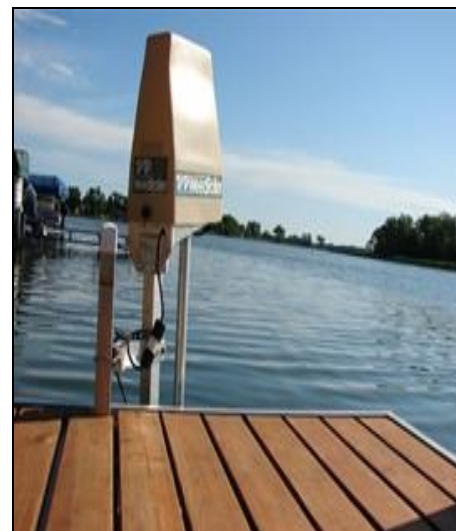
**Figure 52. A Weed Roller.**

Weed Rollers are electrical devices which utilize a rolling arm that rolls along the lake bottom in small areas (usually not more than 50 feet) and pulverizes the lake bottom to reduce germination of any aquatic vegetation in that area. They can be purchased online at: [www.crary.com/marine](http://www.crary.com/marine) or at: [www.lakegroomer.net](http://www.lakegroomer.net).

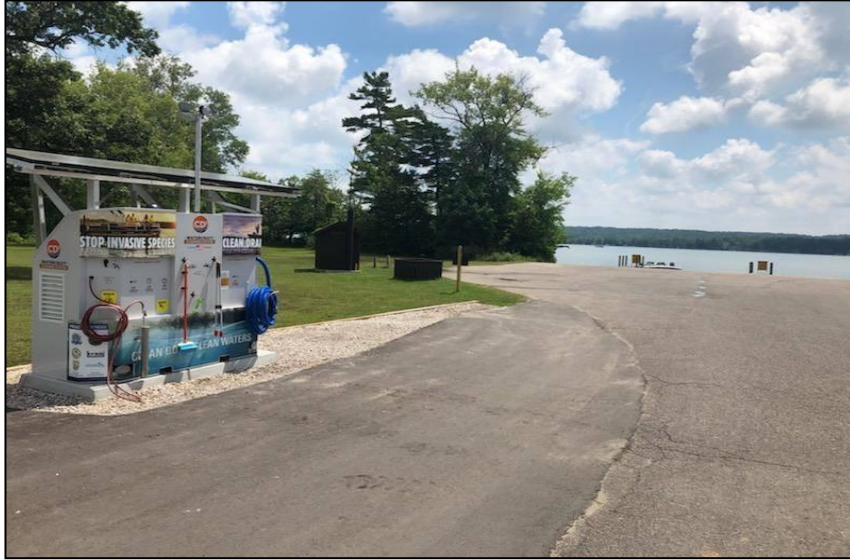
**Figure 53. A boat washing station on an inland lake.**

With over 13 million registered boaters in the U.S. alone, the need for reducing transfer of aquatic invasive species (AIS) has never been greater. The Minnesota Sea Grant program identifies five major boat wash scenarios which include: 1) permanent washing stations at launch sites, 2) Portable drive-thru or transient systems, 3) Commercial car washes, 4) Home washing, and 5) Mandatory vs. volunteer washing. Boat washing stations are voluntary for incoming and exiting boaters. Boat washing stations promote the Clean Waters Clean Boats volunteer education program by educating boaters to wash boating equipment (including trailers and bait buckets) before entry into every lake. Critical elements of this education include: 1) how to approach boaters, 2) demonstration of effective boat and trailer inspections and cleaning techniques, 3) the recording of important information, 4) identification of high-priority invasive species, and 5) sharing findings with others. **Once a boat washing station is in place on Lake St. Helen, the Association should work together to educate the public and lake users on proper cleaning techniques and other invasive species information. A “Landing Blitz” can be held once the station is in place and the public can be invited to a field demonstration of how to use the washing station.** Figure 53 displays a typical CD3 boat washing station that is solar-lowered.

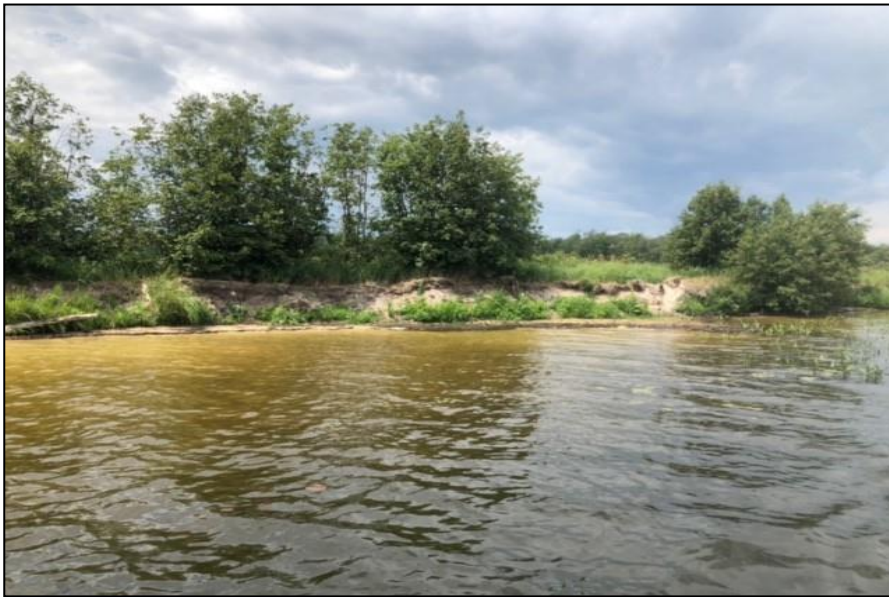
**Figure 54. Lake St. Helen shoreline erosion (July, 2022).**

5. A few areas of shoreline erosion were found during the survey. Areas such as these contribute soils and nutrients to the lake and should be stabilized as soon as possible. A future inventory for this parameter is recommended. This is to protect the good water quality of the lake over time.
